Reconstruction of a chamfered doorway from a late 16th-century tower at Fetternear, Aberdeenshire

Penelope Dransart

Research at Fetternear forms part of the Scottish Episcopal Palaces Project. During August 2015, I worked with a small group of volunteers to focus on the use of stone and slate in the different phases of a building with a complex history of development. This report draws attention to three chamfered stones and the tower from which they were removed.

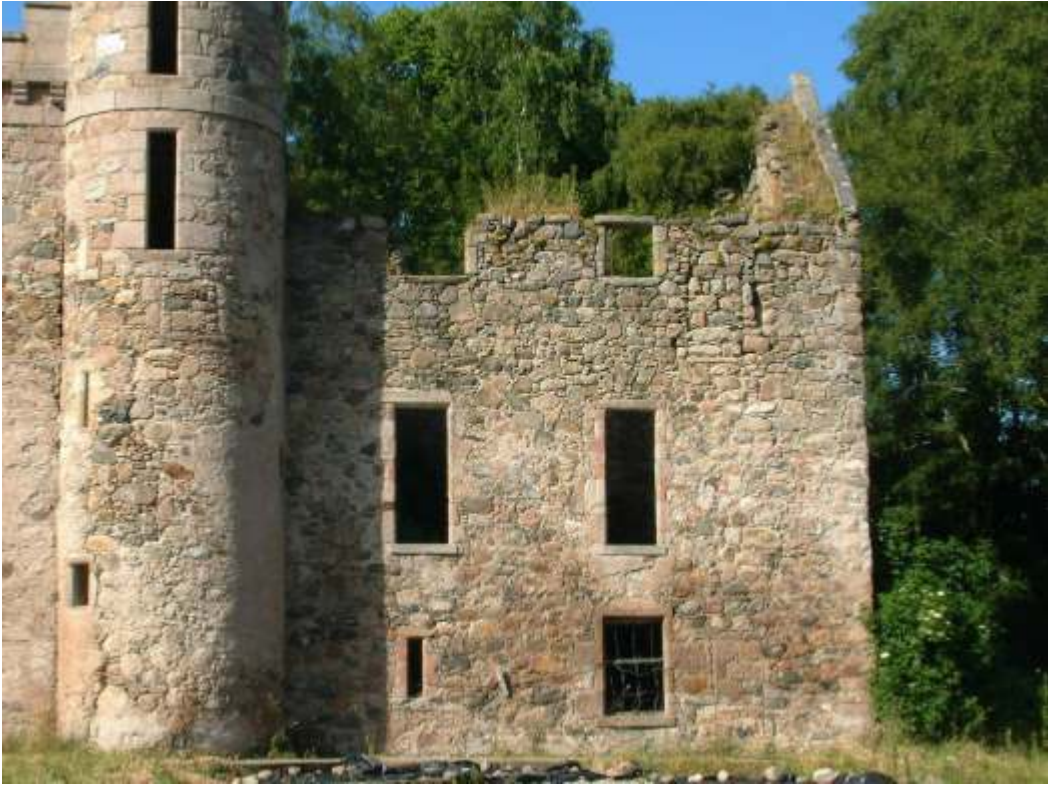
Fig. 1. South-facing aspect of the tower, Fetternear, constructed in the 1570s, photographed in 2005.

It is likely that the tenth baron was responsible for building a tower in the 1570s, partially to replace buildings of the bishop’s palace that have not survived above ground. This tower is now visible at the east end of the mansion, which overlies and incorporates part of what was formerly the bishop’s palace (Fig. 1). Most of its window openings are enlargements of earlier small windows or new insertions into the fabric of the walls. H. Gordon Slade (1970) thought that the south-eastern window of a cellar was the only ground-floor window to be

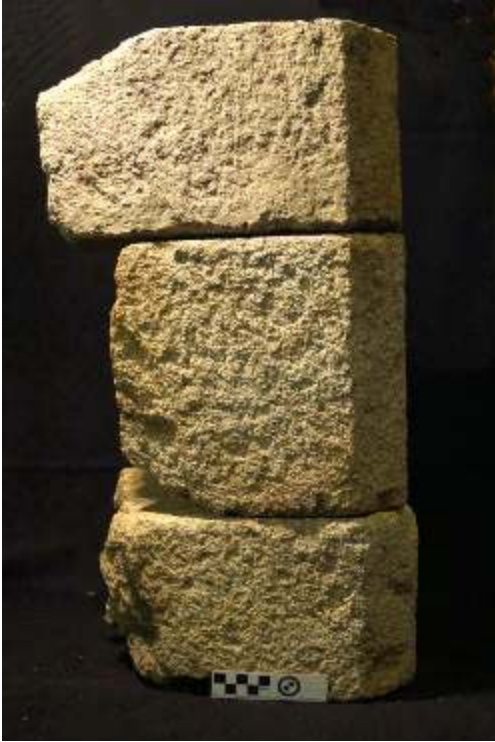
Fig. 3. Reconstruction of the outer face of the chamfered doorway, photographed in 2015.

Between 1994 and 2010, survey, architectural analysis and excavation took place at Fetternear to explore the now-vanished bishop’s palace, the late 16th-century tower and the post-medieval mansion. During the 2010 field season, three chamfered stones were found closely adjacent to each other in a trench excavated through deposits in an infilled moat, a short distance south of the tower (Fig. 2). These stones are well cut in granite and fit together to form part of a door opening. As assembled for photography, they are 0.64 m in height (Figs 3, 4 and 5). The stones alternate short and long in three dimensions, making a stable structure, perhaps coming from the top of a door opening because the uppermost stone presents a diagonally sloping face which could have supported a lintel (Fig. 4). Finely worked diagonal tooling is visible on the outer surface of the stones (with the chiselling trending from top left to bottom right). Broadly spaced diagonal tool marks are visible on the surfaces not intended for outward display and the lower-

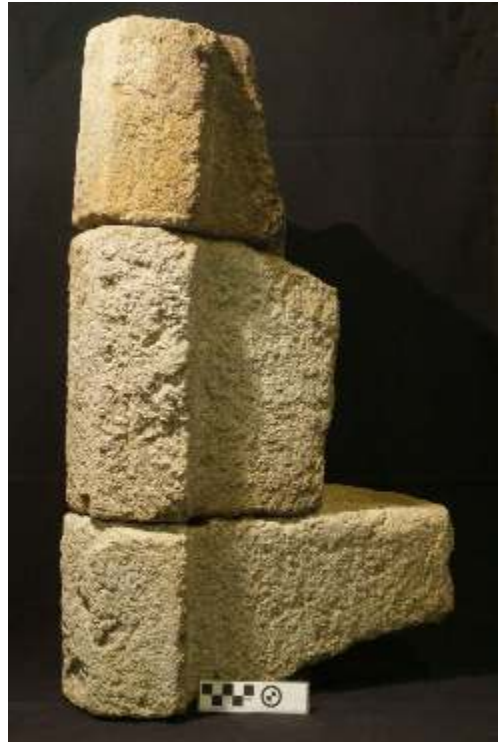
Fig. 4. Reconstruction of the chamfered edge of the doorway, photographed in 2015.

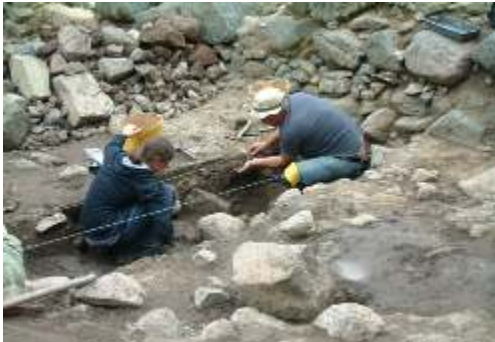
Fig. 2 Excavation of a trench through the infilled moat in July 2010. The uppermost chamfered stone in figs 3, 4 and 5 is visible in the photograph.

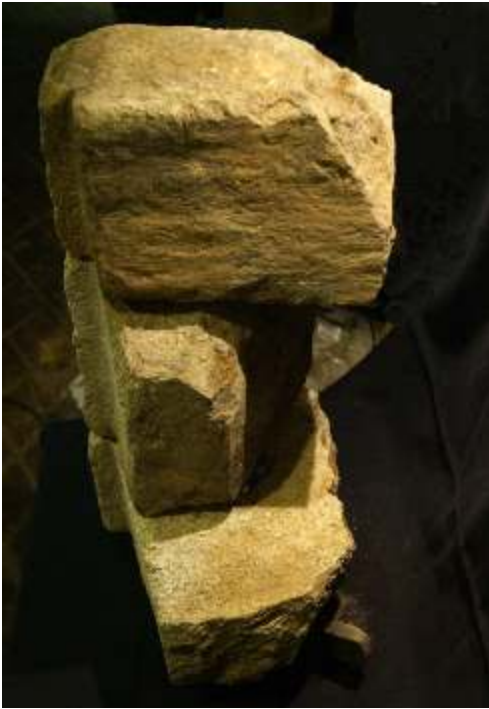
Fig. 5. Reconstruction of the chamfered doorway to demonstrate how the doorway would have been keyed into the rubble masonry of the walling, photographed in 2015.

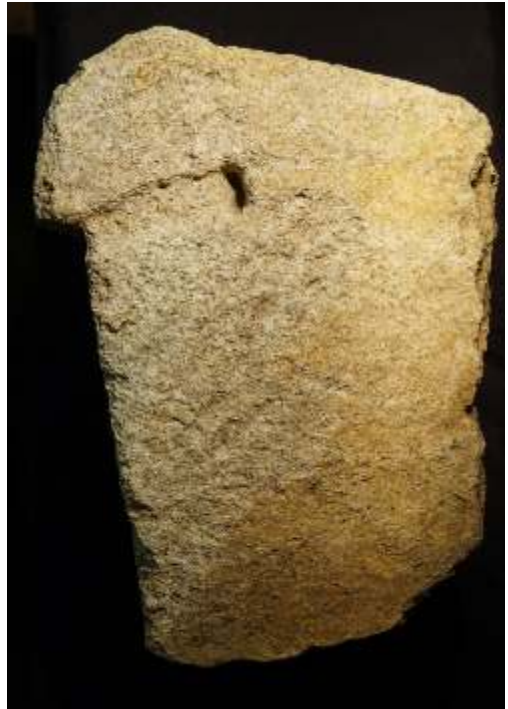
Fig. 6. The upper surface of the lowermost of the three chamfered stones, photographed in 2015.

most of the stones has a carved slot on its upper surface to receive a metal cramp (Figs. 6 and 7).

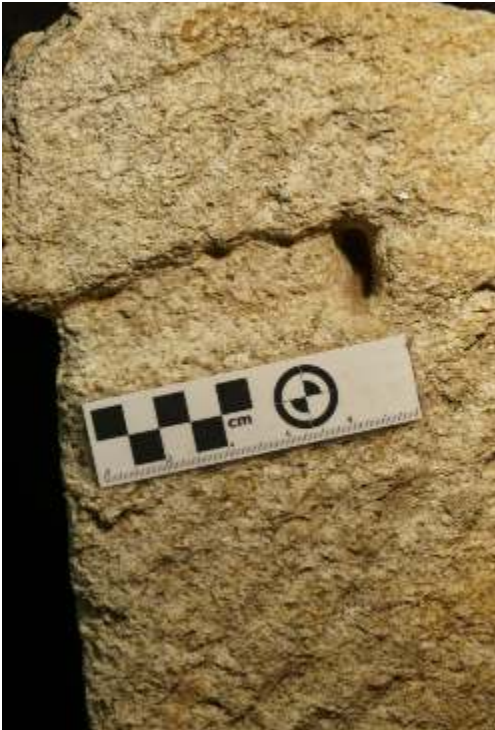
Fig. 7. Detail showing the slot for a cramp in the lowermost of the three chamfered stones, photographed in 2015.

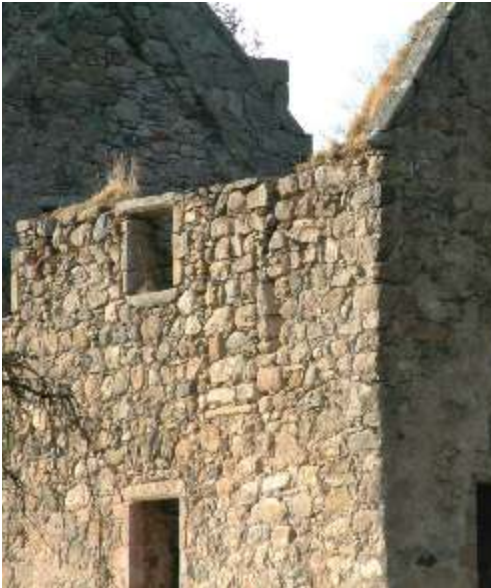
Fig. 8. Detail, taken in 2003, showing the blocked up doorway on the second floor of the tower.

These stones might have been removed from a doorway at the second floor level of the tower when the opening was filled with rubble masonry (Fig. 8). An alternative explanation is that the stones surrounded a door in a building that stood at right angles to the tower. In any case, there must have been a cantilevered wooden walkway to allow access from one building to the other. Footings of this now demolished structure have survived in part and were excavated during various field seasons between 1995 and 2010 (Fig. 9).

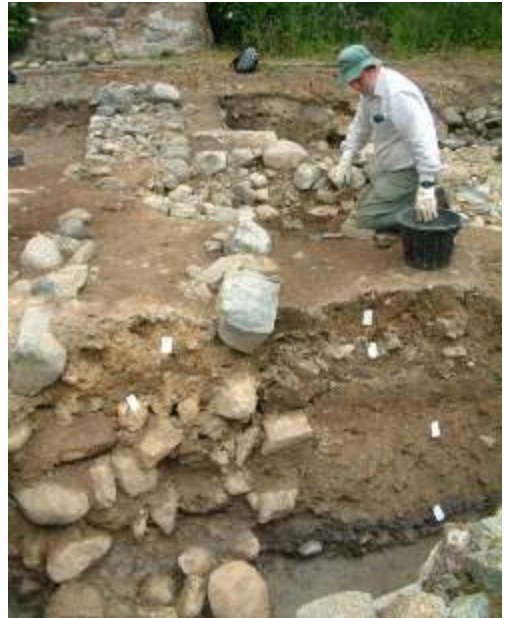
Fig. 9. Excavation in July 2004 of the area south of the 1570s tower, showing the footings of the west-facing wall of a demolished building, which formerly stood at right angles to the 1570s tower.

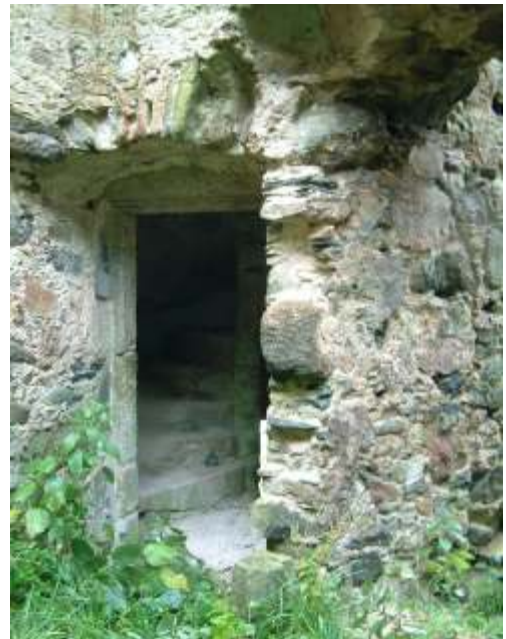
Fig. 10. The inside of a doorway on the first floor of the 1570s tower, leading to the stair tower. Photograph taken in 2005.

The reconstructed doorway is comparable with one surviving at first floor level inside the 1570s tower, providing access to a round stair-tower (Fig. 10). This building was modified in the 17th century and at least twice more in the 19th century. It is likely that the chamfered
