### **Kilbolane Castle**

**Location:** Townland of Kilbolane, lr. Cill Bh-lain (the church of Blan or B|an's church).

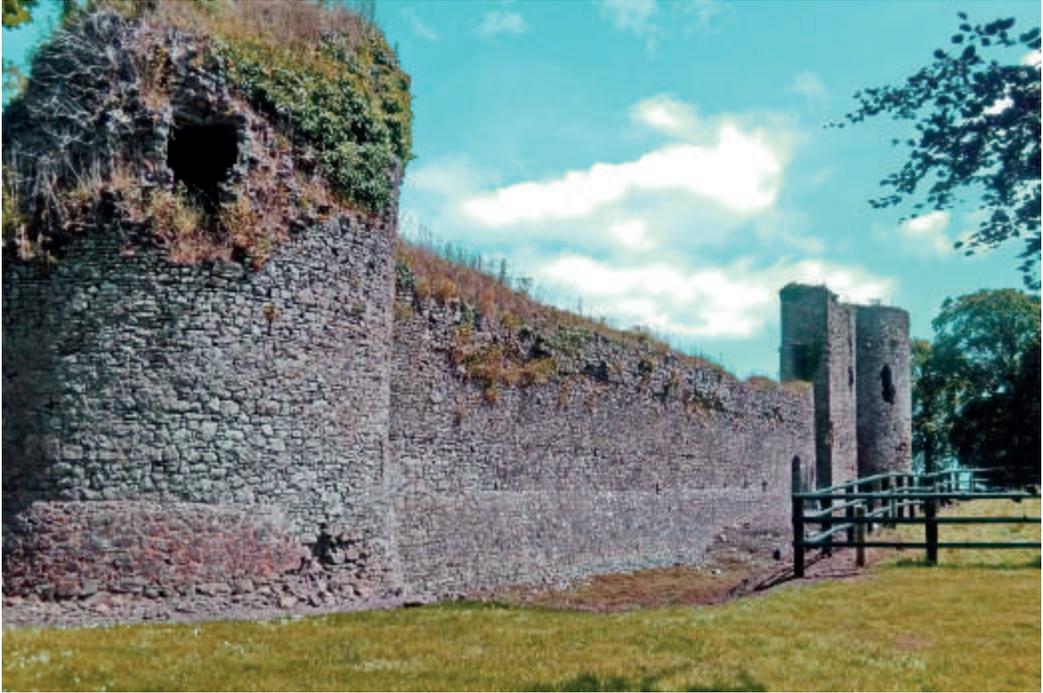
*Kilbolane castle. View of the remaining curtain wall and ditch, from the north west. North tower (left) and South Tower (right).*

**Description:** The remains of a keepless 13th-century castle stand at the west end of a low plateau that took the form originally of a square ward enclosed by a curtain with a circular tower at each corner. Now only the SW curtain wall, 38m long, the south and west towers, and a 29.8m length of the NW curtain wall stand. The curtain wall, 6m high by 1.8m thick, and towers are built of random rubble with a pronounced base batter. The SW curtain has a moat 9m wide by about 1.1m deep immediately outside for most of its length. The NW curtain has an inserted door 16m from the west tower, probably inserted when Kilbolane House was built on this side of castle. The foundations of a 3m-long wall with the base of a doorway butts against the inside face of the curtain wall 7.3m SW of the doorway. The NE curtain is entirely missing but part of the moat survives on this side.

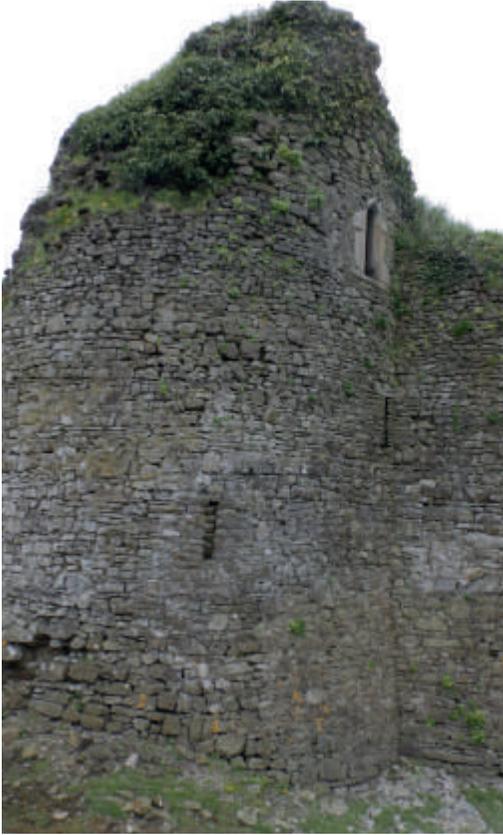
*Kilbolane. North Tower showing the flanking loops along the north-south curtain wall.*

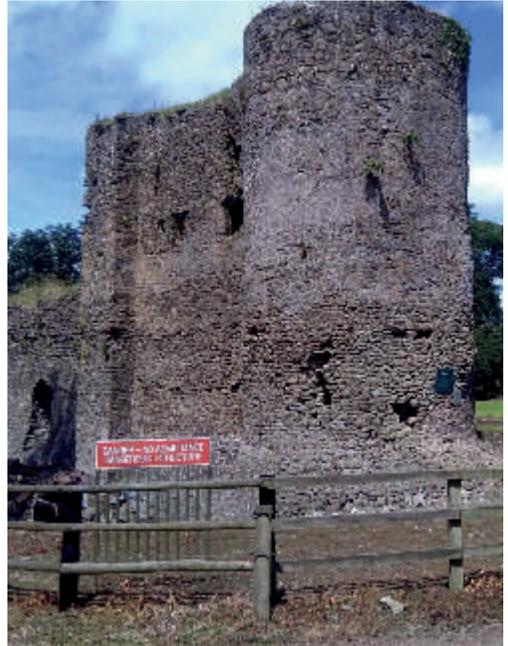
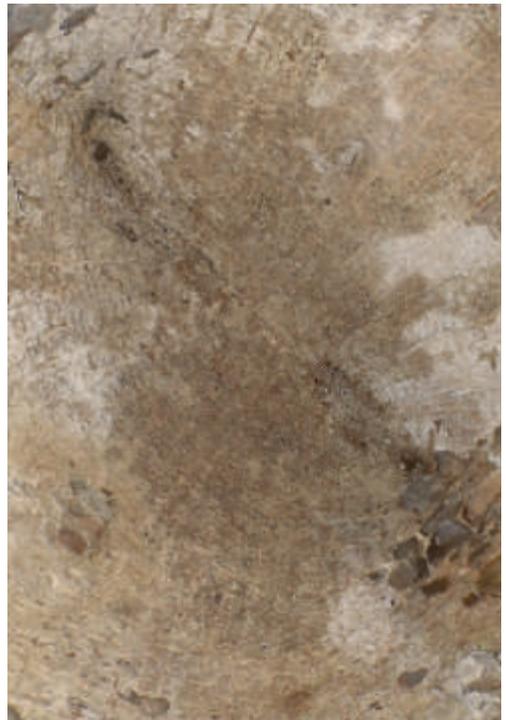
*Above: The South Tower from the SW. Below: The tent-like vault with wicker centring of the the first floor.*

**South Tower:** The south tower is entered at ground-floor level from inside the ward through a doorway on the north side. The round-headed door is rebuilt, as are other features in the tower, probably when it was fitted out in the late 17th century as a residence. The doorway passage has a collapsed vaulted roof. A chamber overhead, measuring 2m by 1.4m and covered by segmental wicker-centred vault, probably had a murder hole in the floor. There is a blocked passage on the north side of doorway. A door with concrete arch leads into a circular ground-floor chamber with a 2.75m diameter, roofed by an unusual tent-shaped vault with wicker centring. The chamber is lit by windows to south and SW, their embrasures roofed by flat vaults with plank centring and with slit lights. There is also a gun loop on the south side of the SW window. At the junction of the tower with the SE curtain (only the stump of which survives) there is an inserted door with a rounded brick

arch at first-floor level. This gives access to a spiral stair, leading down to blocking at ground-floor level and up to the first-floor chamber of the tower. The stair may originally have been accessed from the ground-floor doorway into the tower. The circular first-floor chamber has a diameter of 4m and is roofed by a high pointed domed vault with wicker centring. It is lit by windows to NW and south, the south embrasure having stone seats but missing its light. The NW embrasure has a single ogee-headed light. A pointed-arch door, its south jamb missing, leads north from the tower chamber into a mural passage in the SW curtain wall. The passage, roofed by a wicker-centred vault, extends 10m to where a drawbar socket and a hanging eye for a door survive, but the curtain wall does not survive at this height beyond the door. The door may simply have led onto the wall-walk. At the s end of the passage, on the east side, a narrow stairway rises about 3m before continuing as a spiral stair to second-floor level. Here, a mural passage in the SW curtain wall, covered by wick-

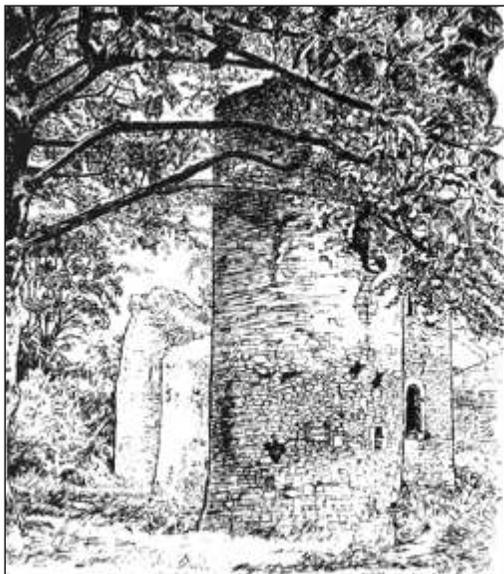
*The South tower looking toward the north.  
From James N Healy, p. 340.*

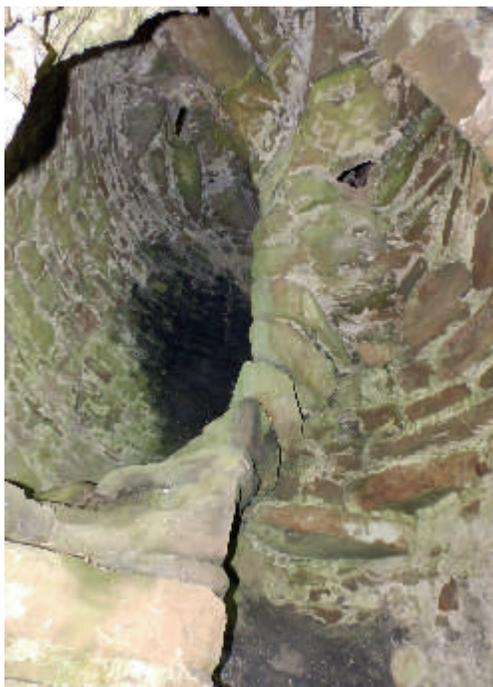
*Kilbolane. Above: Internal view of the spiral  
stair in the South Tower. Below: North Tower  
and section of the curtain wall that extends  
to the NE.*

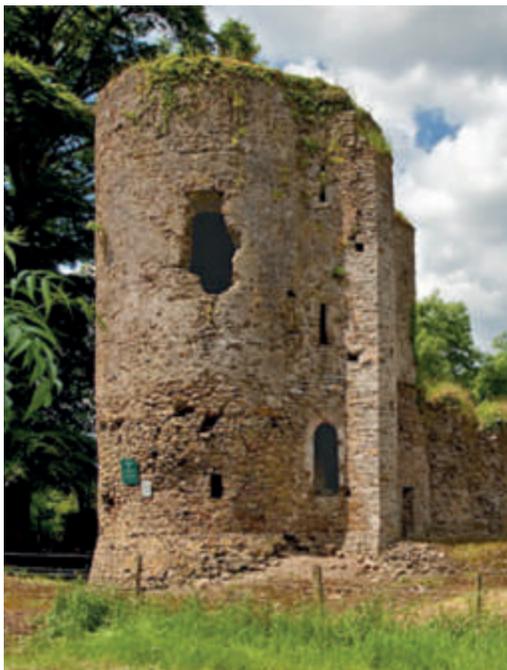
*Kilbolane castle. The South Tower from the SE.  
Courtesy of Mike Searle, CC BY-SA 2.0,  
<https://commons.wikimedia.org/w/index.php?curid=14128177>*
