10. Lewes

The site was established by William de Warenne soon after the Norman Conquest and remained with his family (who were earls of Surrey from 1088) until the mid-14th century. Like Lincoln, Lewes has two mottes. The one now known as Brack Mount (and which carries only a fragment of masonry from a perimeter wall) may be the first motte of the castle built soon after the Norman Conquest. The other motte (bearing the shell-keep, and giving a better view of the town) is assumed to be not much later than the first. The shell-keep is normally seen as a 12th-century replacement of an 11th-century timber structure, perhaps of around 1140, but some (Godfrey 1928, 14; Platt 1982, 28) assert that the shell-keep is late 11th-century in origin and that the employment of precautionary timber reinforcement in its masonry is evidence that the motte was of recent construction when the masonry was added: the wall is 2m thick. Parts of battlements survive, indicating the original wall-height, at the east end of the remaining wall.

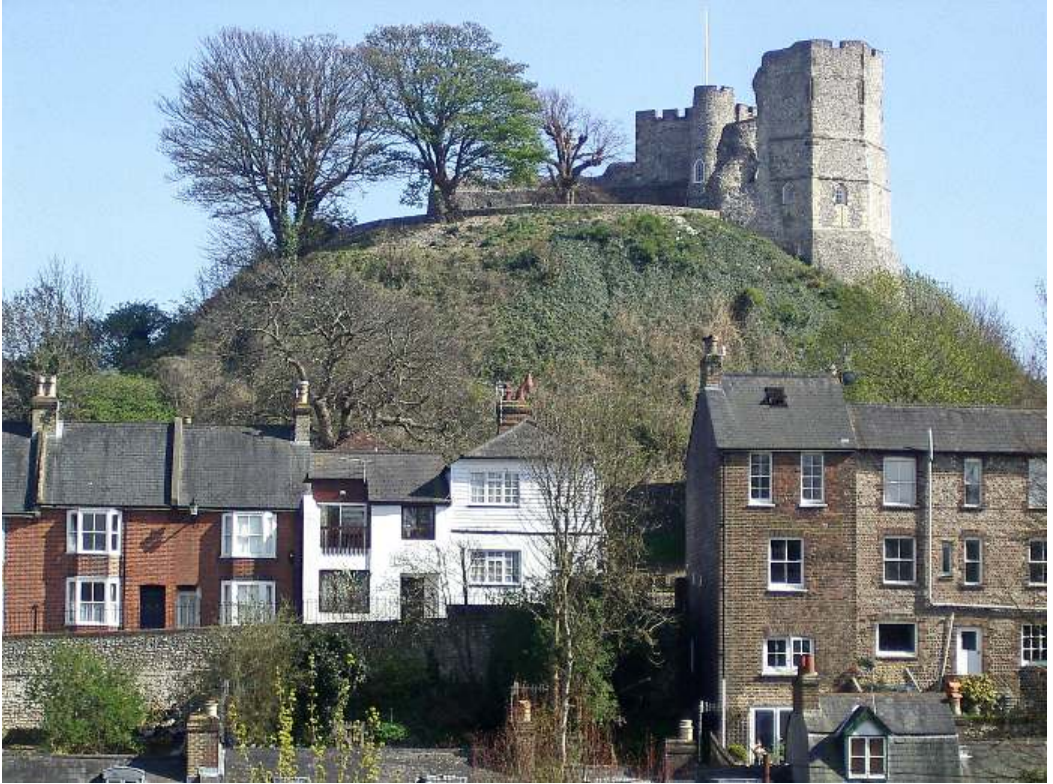
Fig. 1. Lewes Castle. The shell-keep, with later additions, from the north west. Shell-keep early 12th century; semi-octagonal towers added in the 13th century.

In the 13th century, polygonal (half-octagon) towers some 7.5m wide, with widely-splayed bases descending the upper slope of the motte, were added to the perimeter of the shell. Two survive and there must have been at least one more (probably two). The two extant were much altered in the 18th-19th centuries, when parts of the shell-keep were converted into a summer house and garden. Enough remains to show the towers were both residential and seriously defensive. They had three storeys: the ground floor

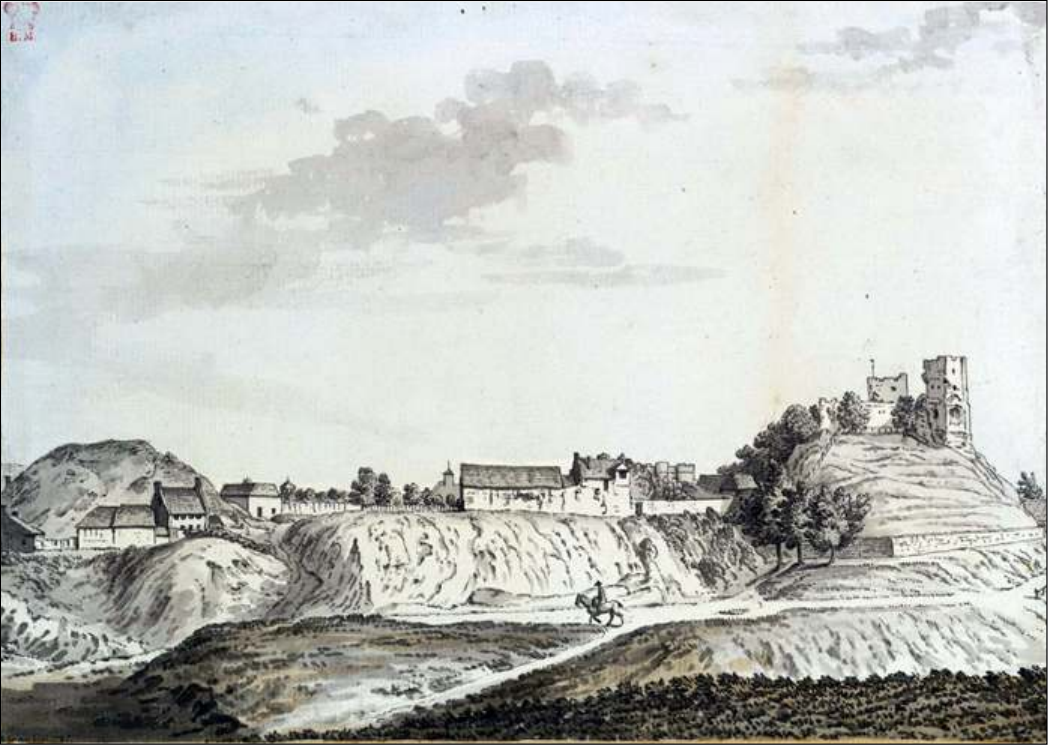
Fig. 2. 'A watercolour view of Lewes Castle in Sussex and the Bray Mount from Mr Shelley's Paddock' (title) drawn in 1785 by S. H. Grimm. (View from the north). © British Library Board, Shelfmark: Additional MS 5672 Item number: f. 6 (no. 10). Reproduced with thanks.

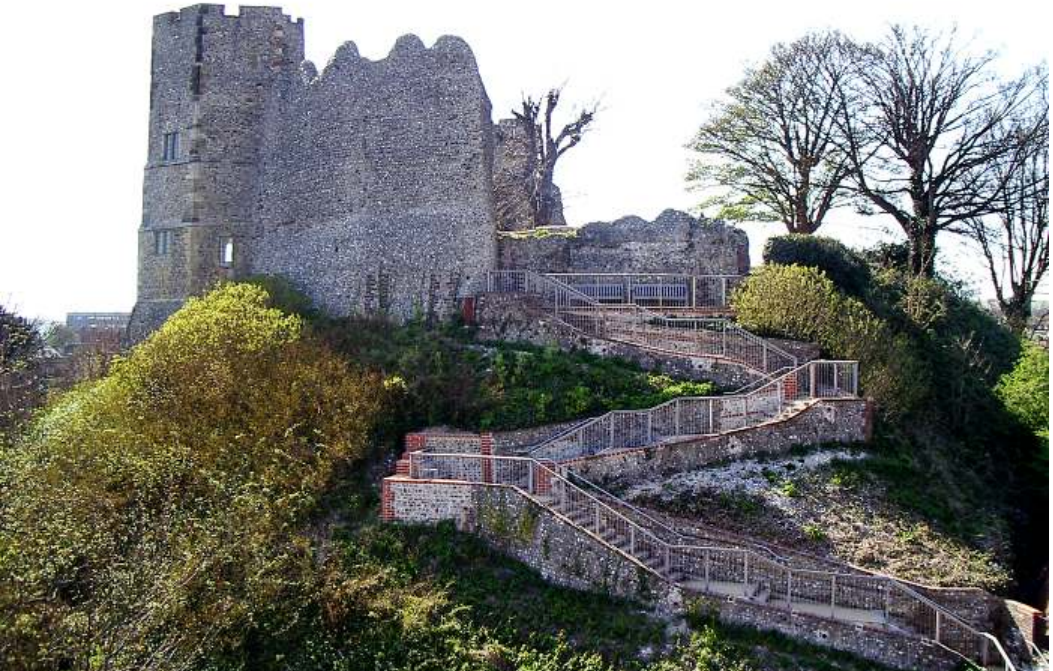
BELOW: Fig. 8. Lewes shell-keep from the north with the zig-zag 19th century steps. Shell walls with remains of crenellations along the battlements indicate an accurate assessment of their original height.

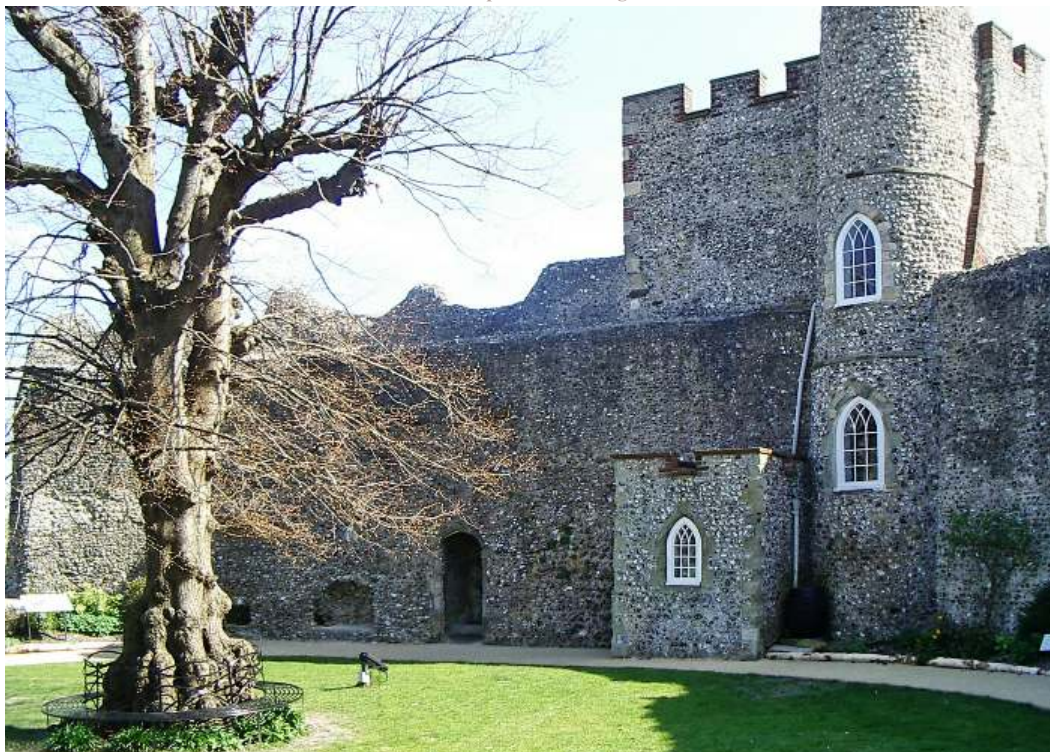
ABOVE: Fig. 9. The shell-keep courtyard looking south-west towards the 19th century buildings

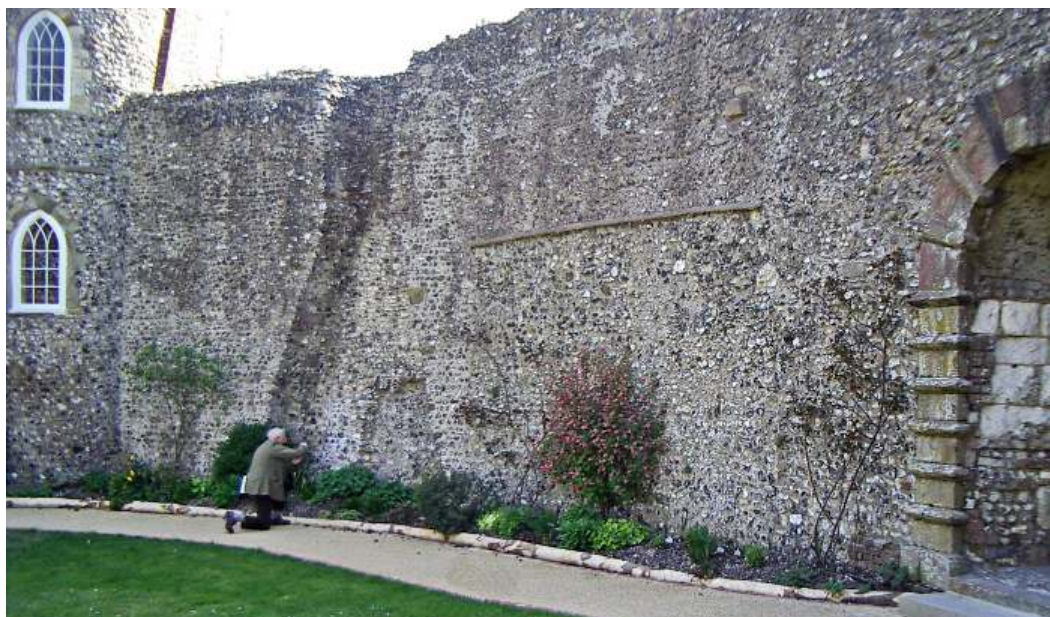
BELOW: Fig. 10. The interior of the south shell wall. Bill Woodburn looking at various features of the kitchen fireplace.

Much of the shell-keep's perimeter collapsed long ago, but remains of a large fireplace and other features indicate it had domestic structures built against it. Ascending wing-walls are assumed, but they do not survive. Access to the motte top was probably up a stair protected by the wing-wall coming from the direction of the gatehouse east of the motte. No trace of the entrance itself survives, so its strength, grandness and details of approach cannot be determined. Evidence of timber reinforcement within the shell-wall has been noted.

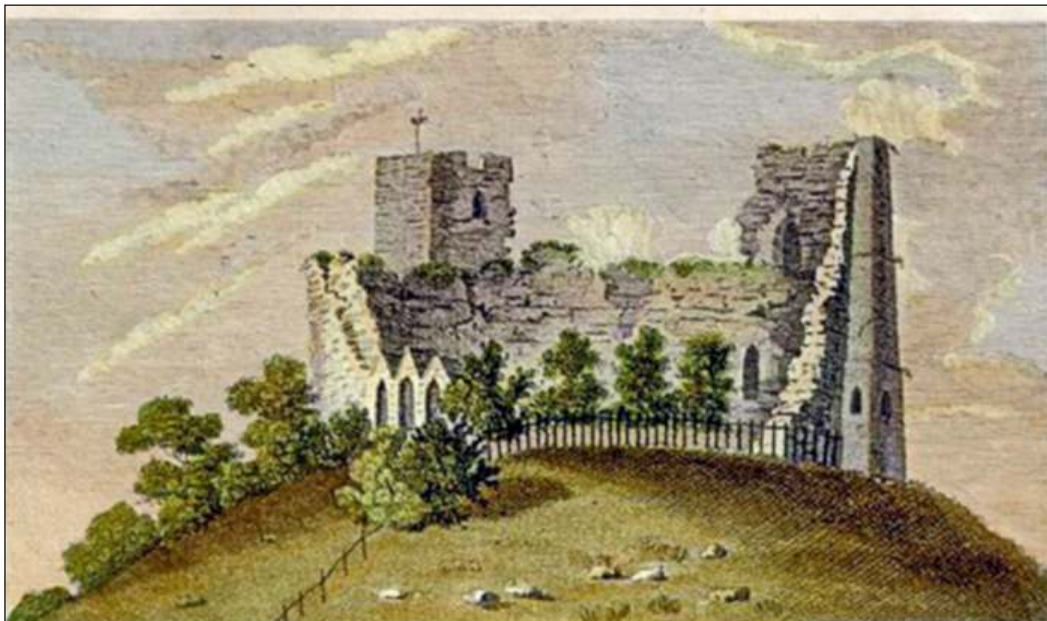
ABOVE: Fig. 11. Lewes Castle, Engraved by Ravenhill and published in the *Topographer* in 1790. Copper engraved with more recent hand colouring, (from the north). Painted prior to any major 19th century neo-gothic additions.

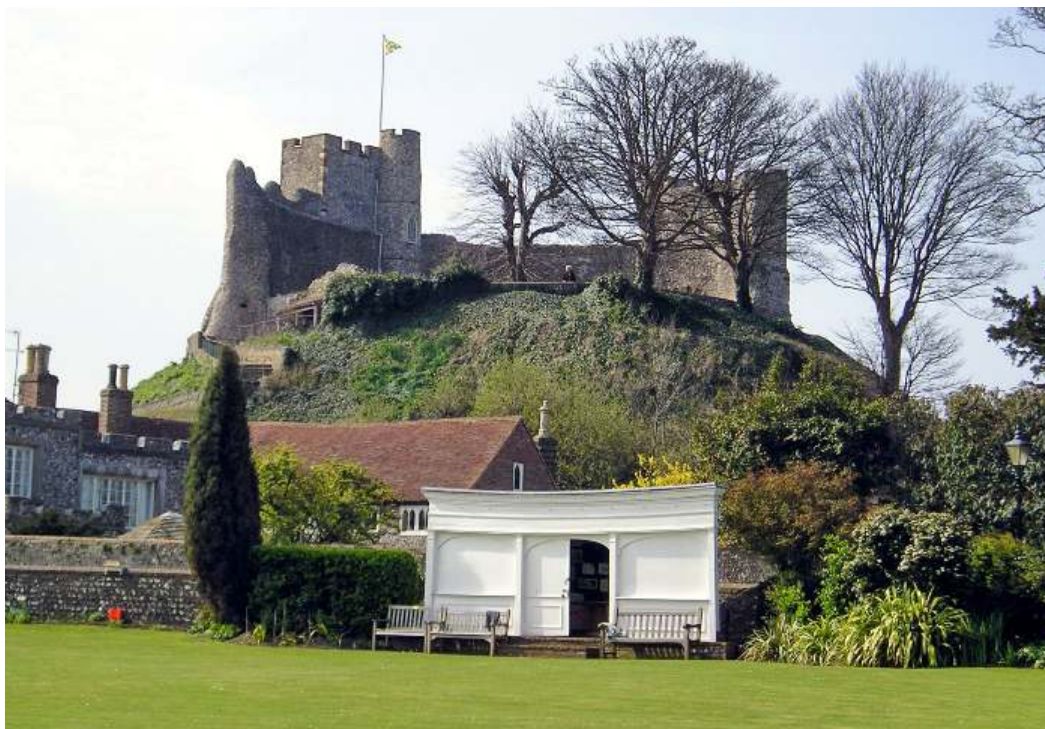
BELOW: Fig. 12. A similar view from the bowling green.
