## Carisbrooke

### 4. Carisbrooke

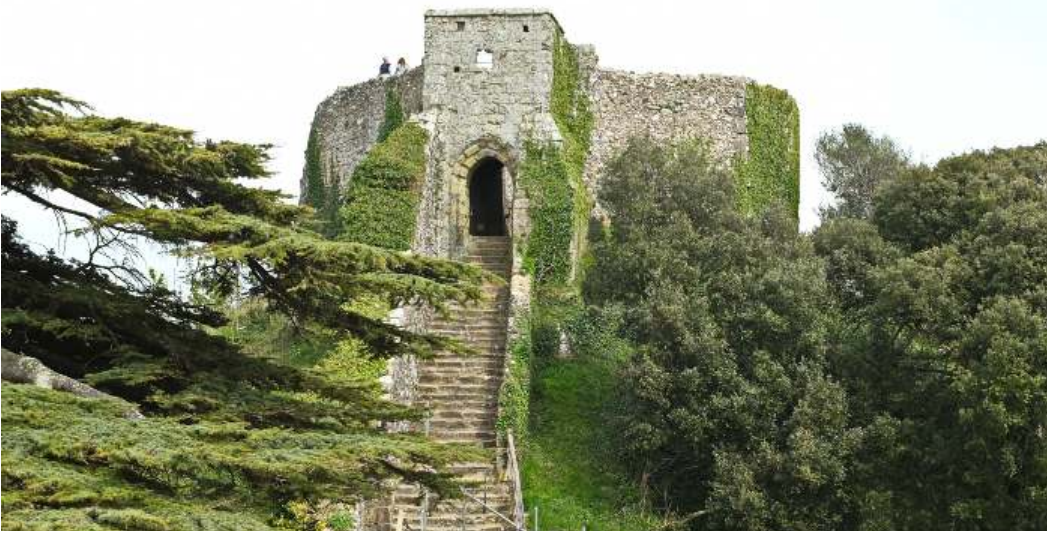
Fig. 1. Carisbrooke shell-keep, c. 1130-40 with added gatehouse and portcullis c. 1335.

The shell-keep on the motte is assumed to be part of the castle defended in 1136 against King Stephen. Whether it succeeded a timber structure or was the primary motte building is not known. The shell-keep continued to be an important part of the site's facilities for a long time: its gatehouse tower, with vaulted entrance tunnel and portcullis grooves, was added in around 1335. This entrance, and whatever earlier entrance it succeeded, was reached from a long stair protected by a wing-wall rising from the 12th-century bailey curtain wall on the north side. A corresponding wing-wall rose on the east side, but no longer survives. The crenellated wall-tops of the shell-keep have long

since disappeared, but the wall-walk survives and the structure remains impressive. The outer wall, an irregular, twelve-sided polygon in shape, is largely of 12th-century date except on the south and east where there is 13th- and 14th-century work. The interior, however, now reveals little of the medieval domestic plan. The well, perhaps the one said to have run dry in 1136, still survives. Two garderobes, one (raised) near the entrance, the other (ground level) at the far end, suggest lean-two structures and the straight south wall probably carried the main range. "In 1897 a removal of the debris revealed the walls of a 13th-century building with a fireplace and remains of rooms against the south wall" (VCH 1912, 227). The walls which now dominate the interior, creating separate rooms including the well-house, are largely post-medieval.

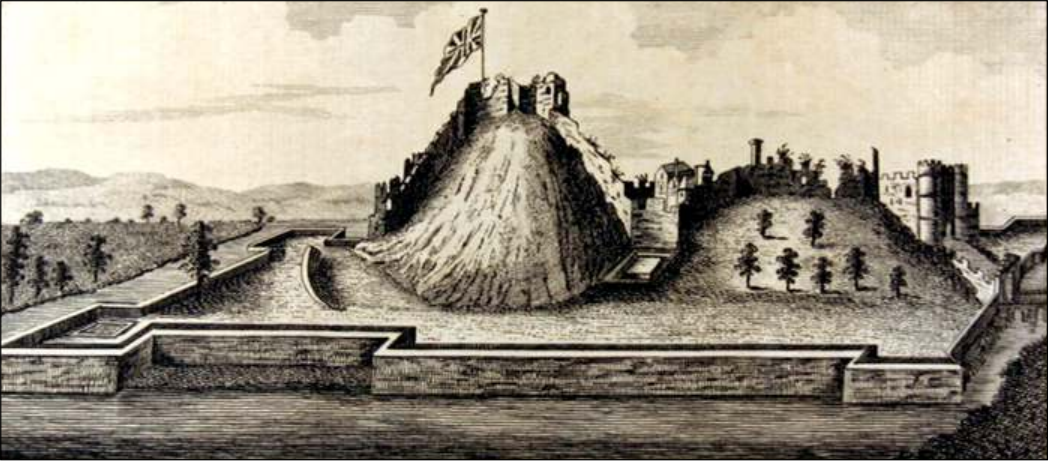
BELOW: Left. Figs. 5 & 6. Plan and enlarged plan detail of Carisbrooke shell-keep from VCH 1912, Vol. 5 opp. p. 226. Quadripartite rib-vaulted section c. 1335. Transverse ribs c. 1280s. Right: Fig. 7. Sepia print c. 1900 of the 71 stairs to the keep gatehouse. Compare the arch with the erosion in fig 9.

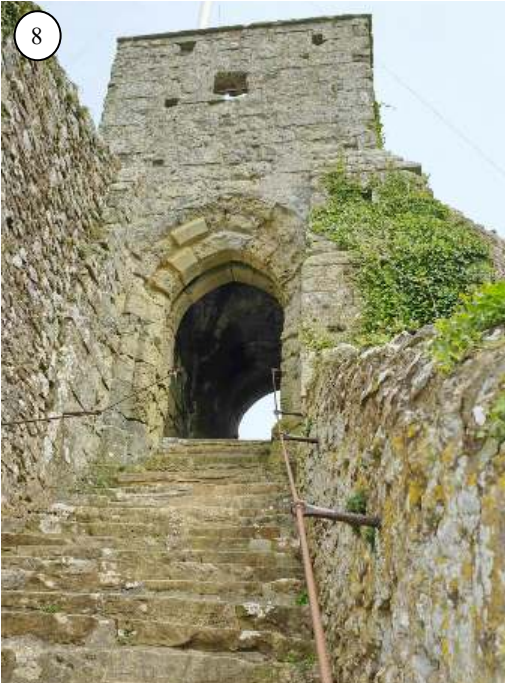
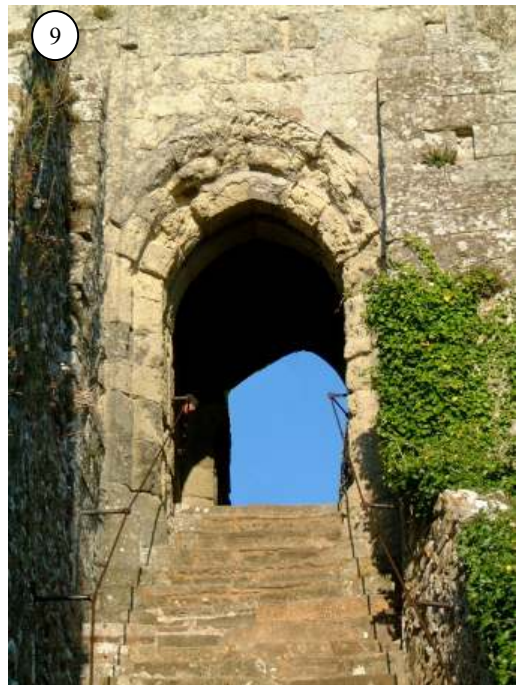
ABOVE: Figs. 8, 9. 71 steps up to the gatehouse. The arch shown right (picture taken in 2005), has since been repaired with two new blocks inserted (2010) (see fig. 8 & cf fig. 7). There was one portcullis in the gatehouse, but two in the outer entrance.

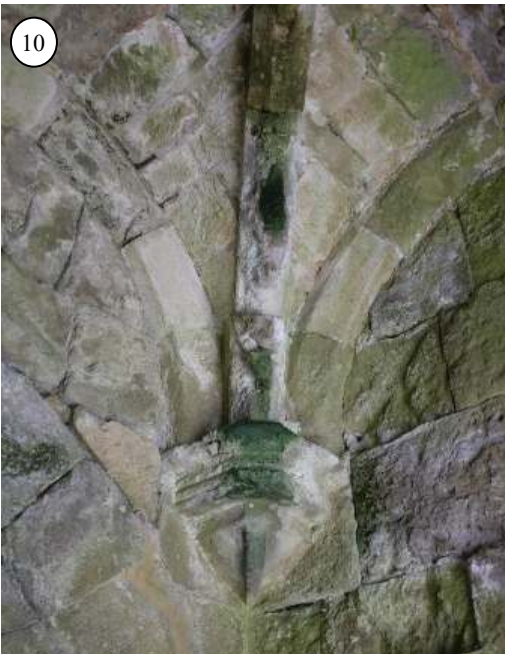
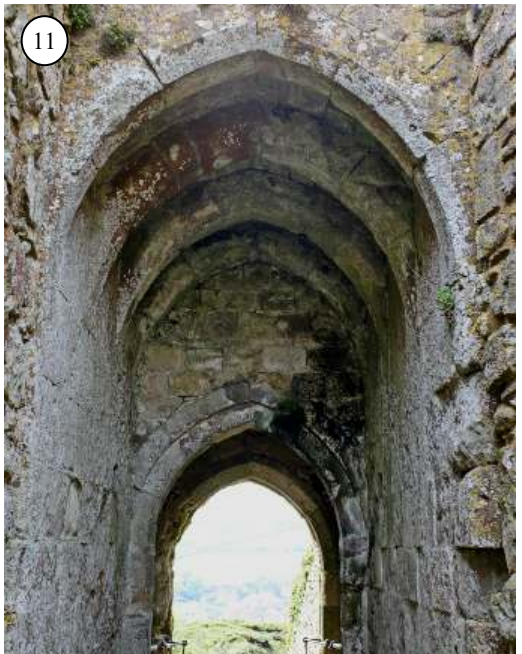
BELOW: Figs. 10, 11. Ribbed vaulting in the outer gatehouse bay. Transverse vaulting in the inner bay. See fig. 6.

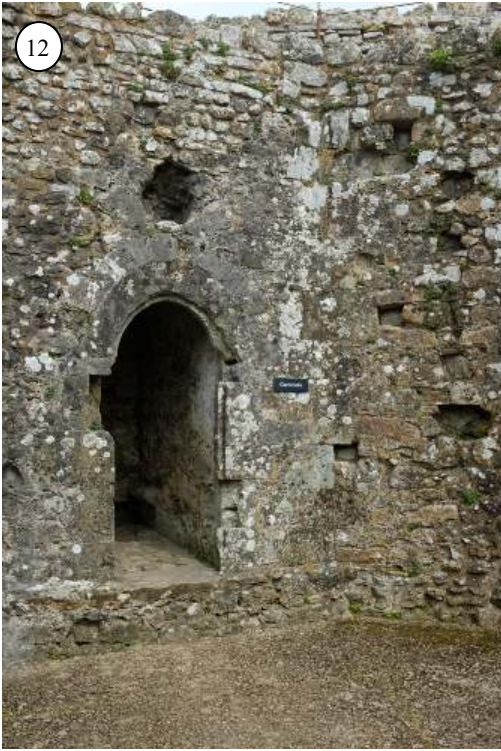
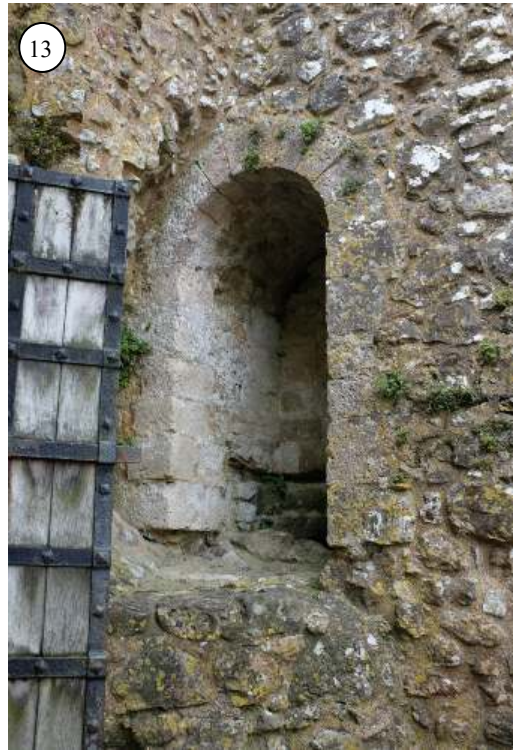
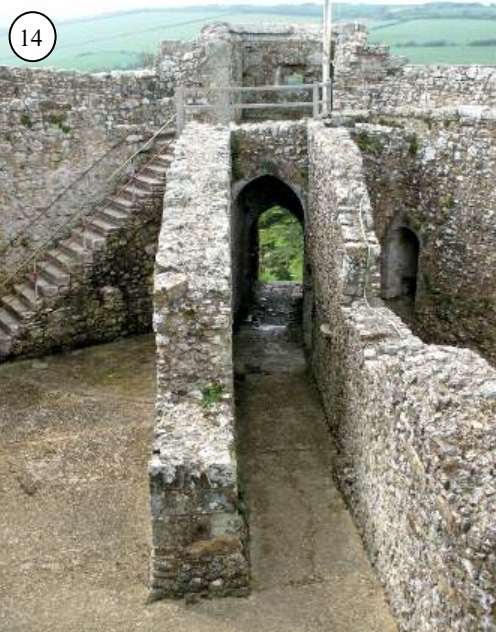
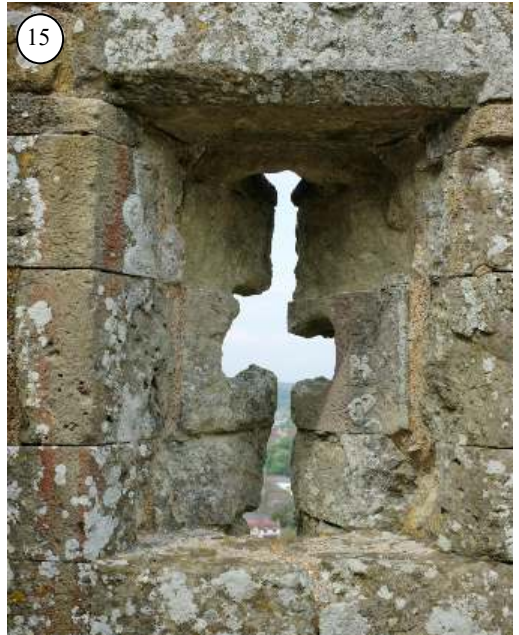
*Figs. 12-15. The interior of the shell-keep. 12: Garderobe (inserted?) on the east wall (no dogleg). 13: Garderobe on the north wall (also seen in 14). 14: Looking west along the curious high-walled corridor to the entrance gatehouse. Probably a post-medieval 16<sup>th</sup>-century addition. 15: One of two arrow loops on the top of the gatehouse.*

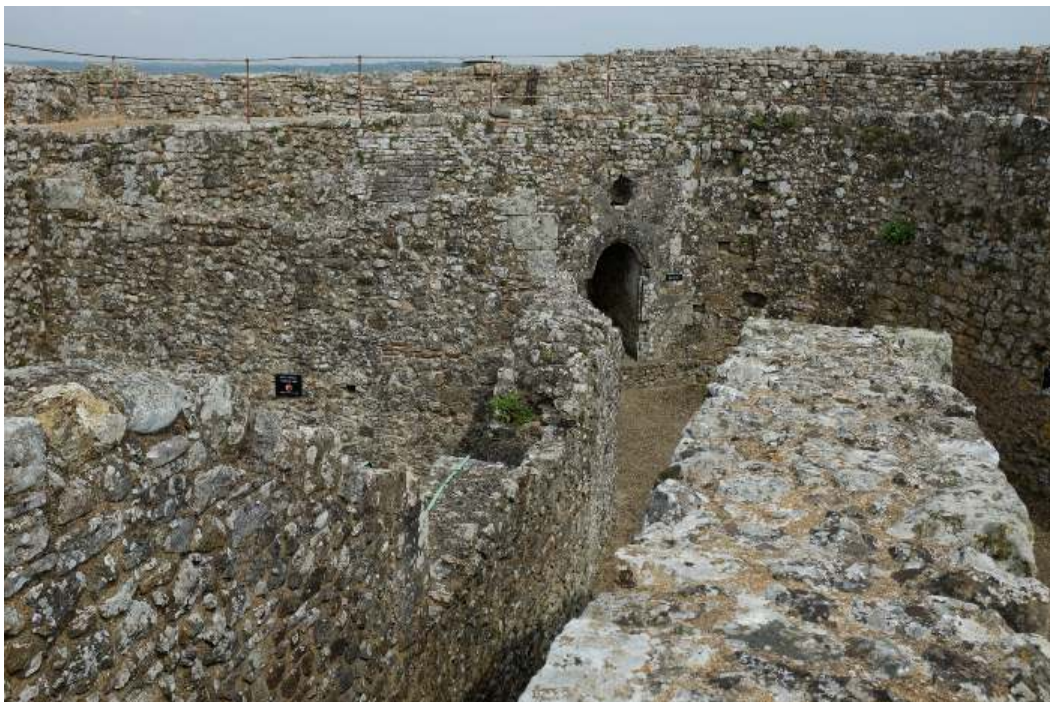
*ABOVE: Fig. 16. Carisbrooke. Looking east from the gatehouse. The well is in the chamber to the left (158ft deep).  
BELOW: Fig. 17. The long straight south wall. Possibly the original location for the lean-to domestic accommodation. The current guidebook suggests this section of wall was rebuilt in the 14<sup>th</sup> century.*
