Kenilworth castle as it may have been at the time of the great siege of 1266

James Petre

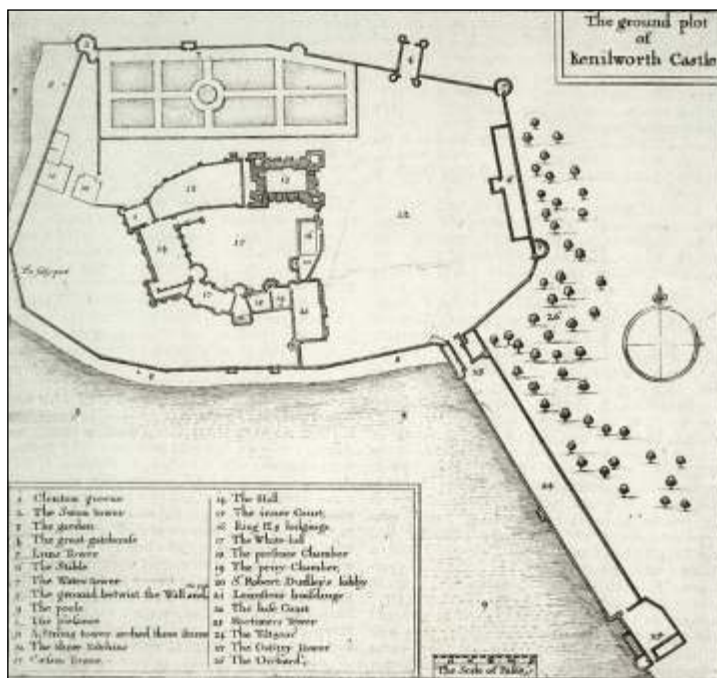
'The ground plot of Kenilworth Castle' - Wenceslaus Hollar (1607-77), published in 1656 in Sir William Dugdale's 'The Antiquities of Warwickshire'. From the University of Toronto Wenceslaus Hollar Digital Collection. Reproduced with thanks.

2-- The Swan Tower

7-- The Water Tower

23- Mortimer's Tower

24- The Tiltyard

25- The Gallery Tower

On the northern, outer curtain, we know from the Hollar plan published in 1656, that there were at least two interval towers: one in the centre of the curtain and a smaller one to the west, mid-way to the Swan Tower. The central tower is shown on Hollar's view as polygonal to the field. This is known from excavation to have been rectangular internally and to have contained a small, pedestrian postern gate with a bridge across the ditch outside.²⁶ A survey of the castle was drawn up in 1563 which recorded a 'fair gatehouse of stone with a portcullis, going into the town, much in decay'.²⁷ Was this the postern or a larger and quite distinct entrance nearby? The phraseology of the survey suggests the latter but it has caused some confusion to earlier commentators. Derek Renn, for instance, considered that Leicester's Gatehouse, built in 1571-2, replaced the postern, although that interpretation is not followed in Lapper's depiction in Renn's 1991 guidebook.²⁸ In all likelihood, the main, north gatehouse was indeed on the later site of Leicester's Gatehouse, and this was distinct from the pedestrian postern in a neighbouring tower. Analogy with Dover is again worthy of note as there, its main entry point on its north (the Norfolk Towers) is quite close to a lesser entry on its north-east (the FitzWilliam Gate). So this juxtaposition of main gate and immediately adjacent postern is quite feasible. East of the later Leicester's Gatehouse is a heavily buttressed causeway across the moat, probably marking the site of the northern dam made necessary by the difference in water levels on the east and west sides of the castle.²⁹ It seems plausible that such a dam could be associated with the gateway and that this argues in favour of locating the original, main, northern entrance where Leicester created his elaborate entrance arrangement.³⁰

Hollar's plan shows a sally port on the western curtain, leading down to the Mere which Thompson repeated.³⁶ This was in fact the 'Water Gate' which is probably no later than the fourteenth century. Whether an entrance existed in 1266, however, is hard to say: Richard Morris though not. Excavations have suggested a possible quay on the south-west side of the Gallery Tower complex so it is possible that boats first used this point of access across

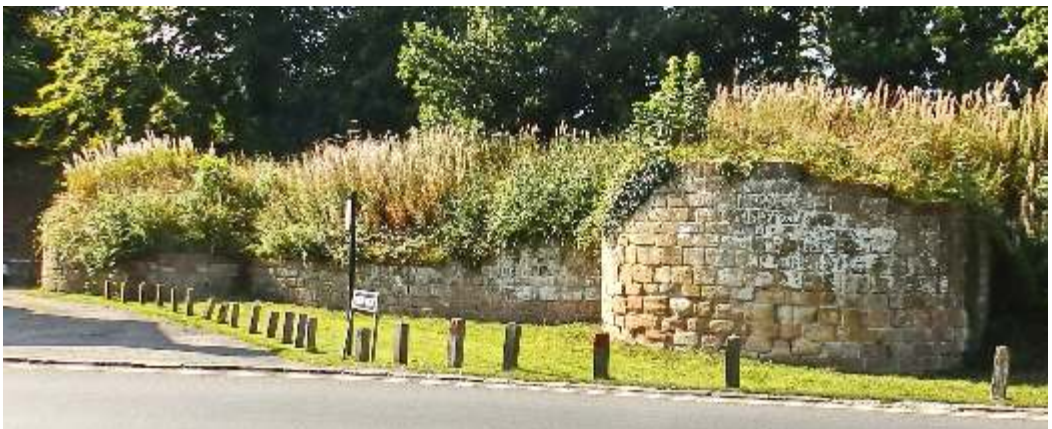
Remains of the The Brays bastions; the more southerly 'entrance?' marked on the plan.

Tower. What exactly was this? In previous analyses, it has been seen as a gateway and more recently as a pair of connected viewing platforms created for the tournaments held within the Brays. Certainly the bastion-like circular *termini* and the extensive stone platform lying between might have served as a gateway arrangement, the outer elements of which have been lost. If so, it would bear comparison with the entrance to the hornwork, known as the Western Island, at Caerphilly, begun in 1268 and, it seems, partly modelled on Kenilworth. The alternative proposition - that it served as a grand stand from which to view tournaments - is not convincing. It appears to be far too substantial a work for such a purpose, and the absence of other, similar, stone-built structures around the Brays' embankments, are factors which imply that it had a different purpose. Further to the east, there is a large masonry structure projecting forward from the bank and blocking the ditch. It is faced with well-dressed stonework and may have served as a dam to hold back water from the north. As with the dam beyond the north curtain, this may perhaps be associated with a contemporary entrance. Accordingly, the plan below shows possible entrances - marked '?' - both at this point and between the bastions to south-west.⁴¹
